LA No. 179152

Field No and Name(s): 1766-004, "Dump 2"

LANo. 179153

Field No and Name(s): 1766-005 (“House 1”)

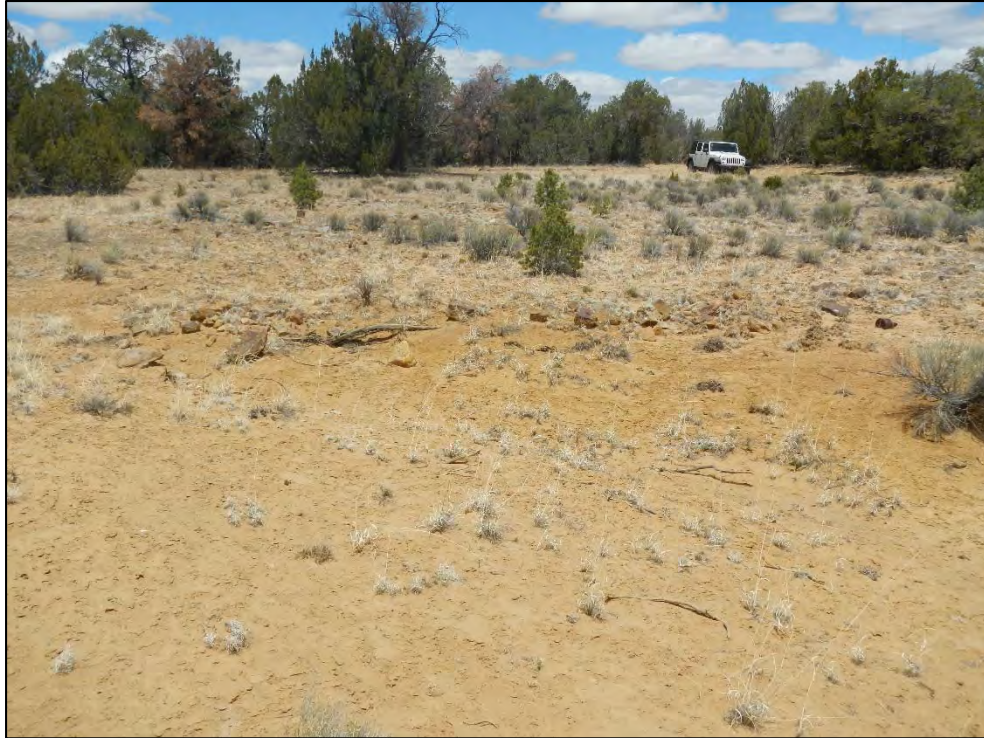
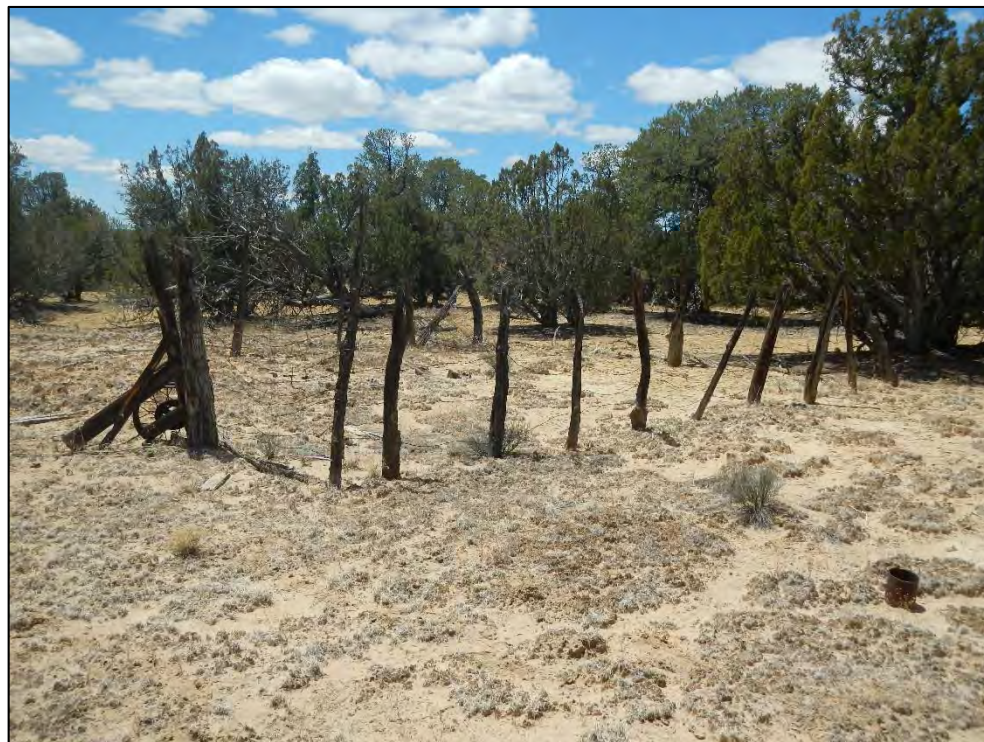
Figure 20: LA 179151 Feature 5 Facing North (top) and Feature 6 Facing Southwest (bottom).

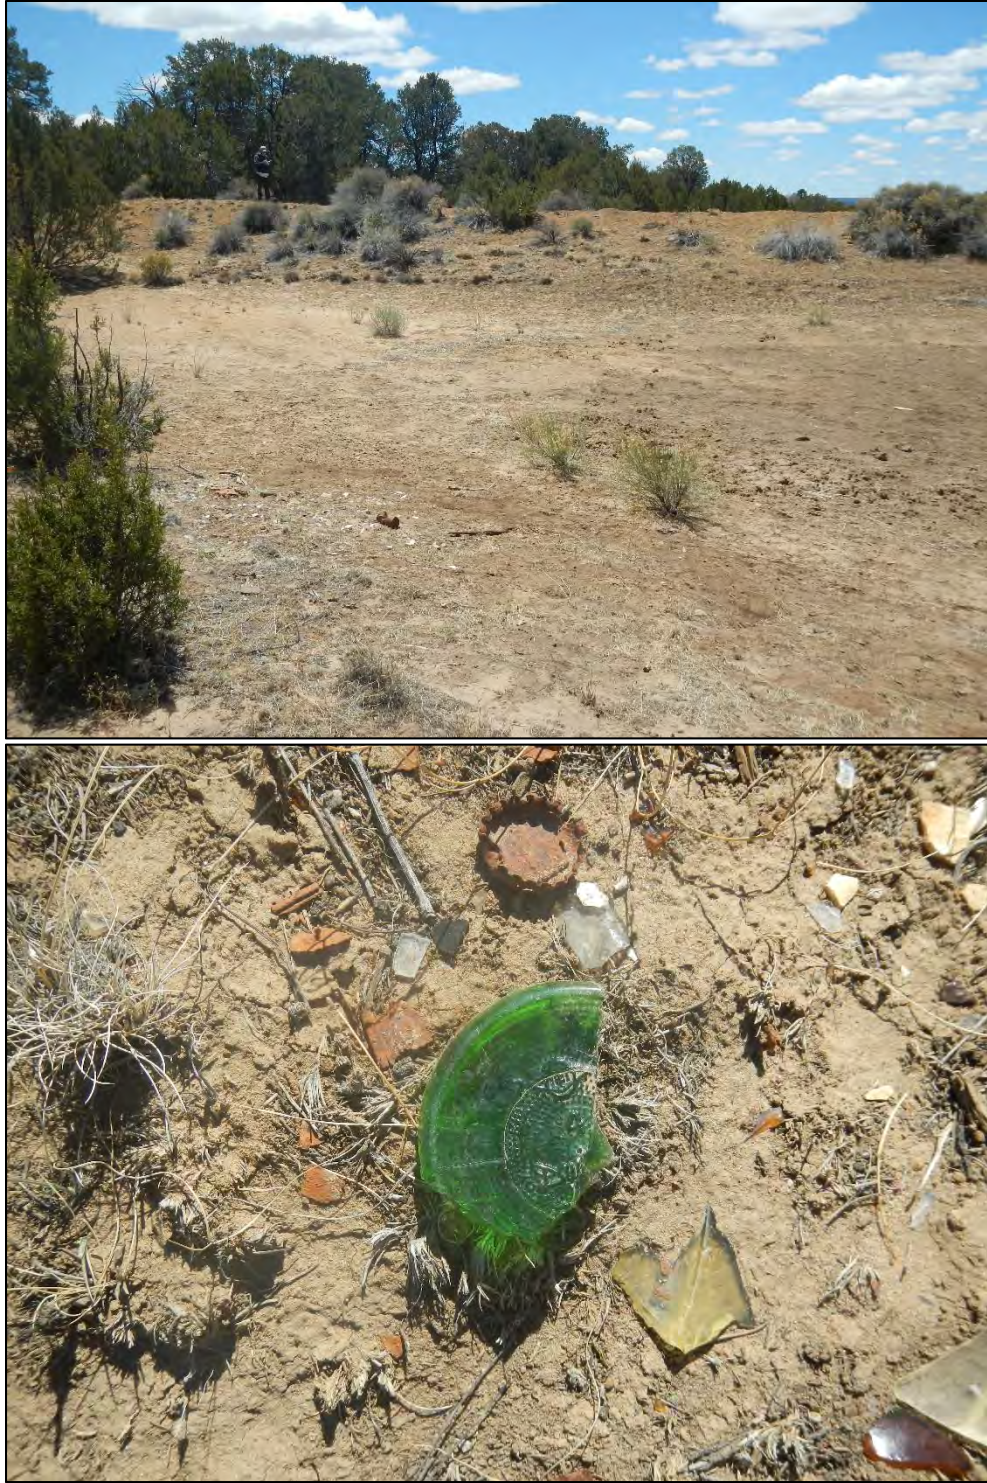
Figure 22: LA 179152 Site Overview Facing Southwest (top) and Bottle Base with Maker's Mark (bottom).

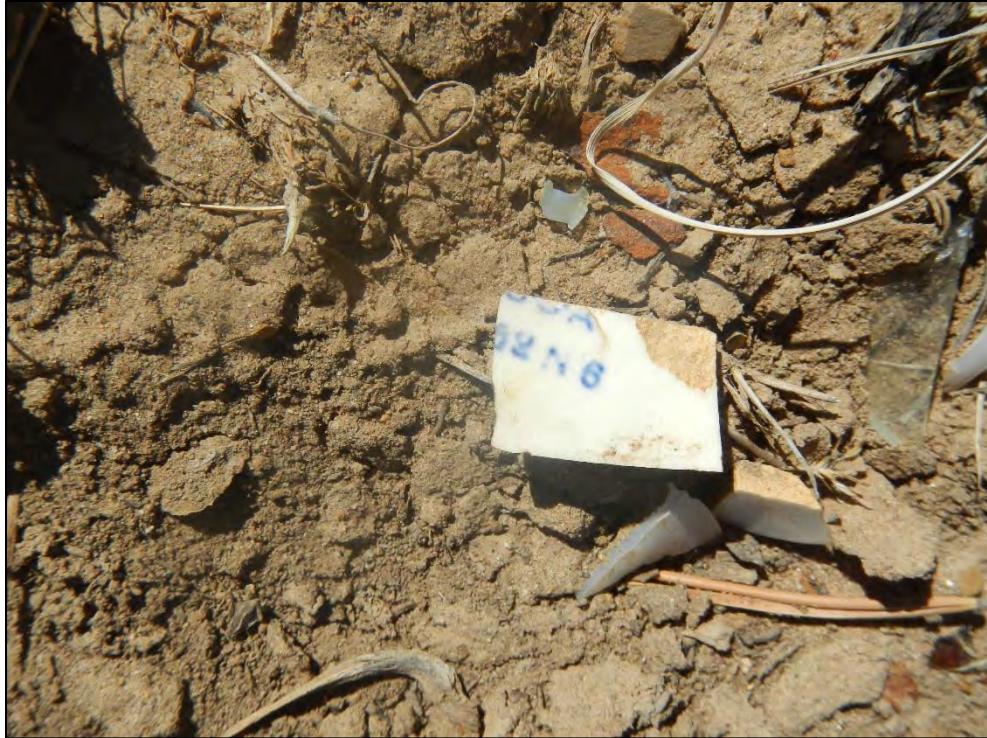
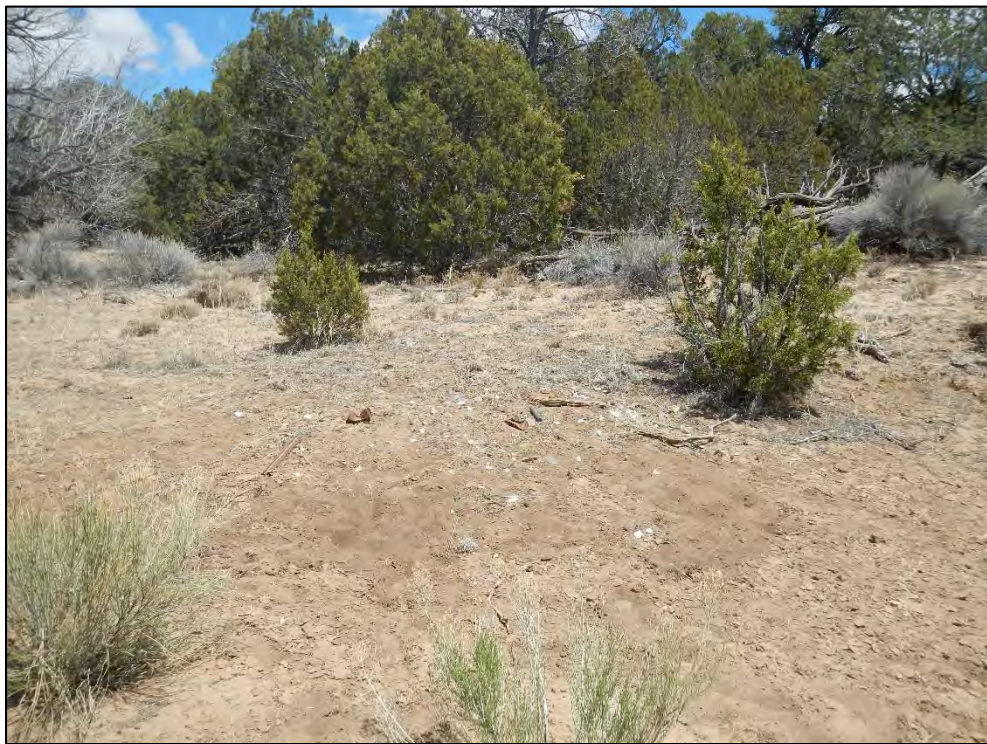
Feature 1 is an historic trash dump measuring 3 m by 3 m, located on a hill slope (Figure 23). If this concentration is in the fact the result of a single dumping episode, its creation postdates the manufacture of the newest artifact in 1962, and the appearance of older artifacts represents a cleaning up of old refuse from elsewhere. It is also possible that this concentration is the result of several dumping episodes beginning as early as the 1940s and extending into the early 1960s. The feature lies on the bank of what is thought to be a 1954 cattle tank. The position of the feature on the bank of the tank suggests this feature postdates the construction of the tank. Sheetwash and overflow from

the tank during periods of high water have caused the disarticulation of the feature, dispersing artifacts from the main concentration. The feature is estimated to be 60 percent intact.

Figure 23: LA 179152 Ceramic Sherd with Mark (top) and Feature 1 Facing East (bottom).

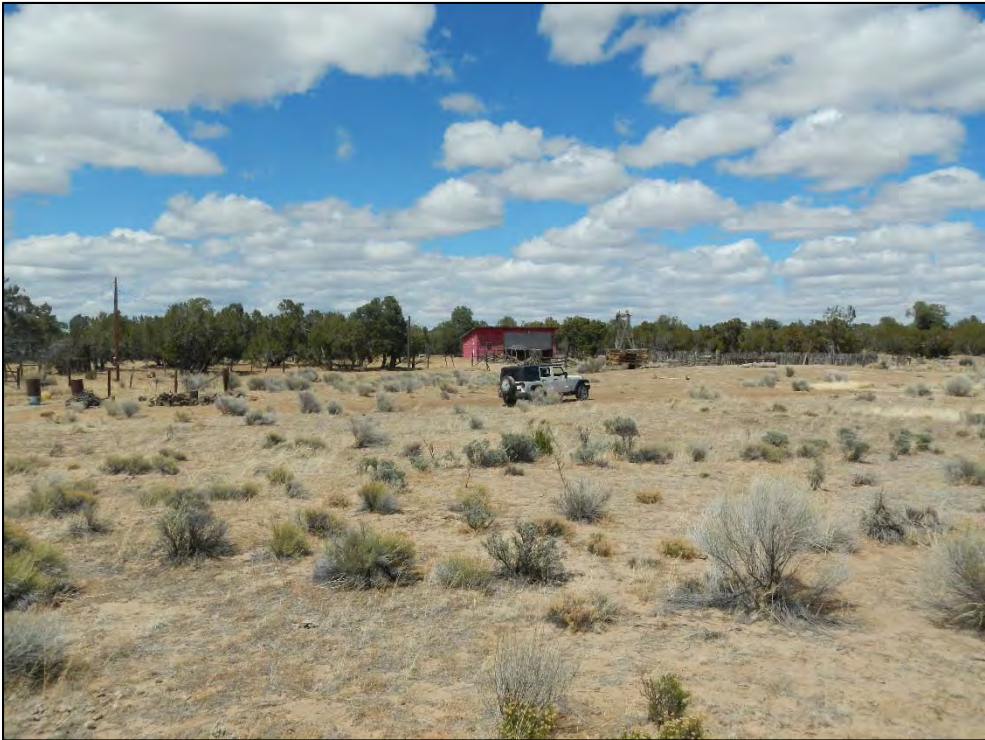
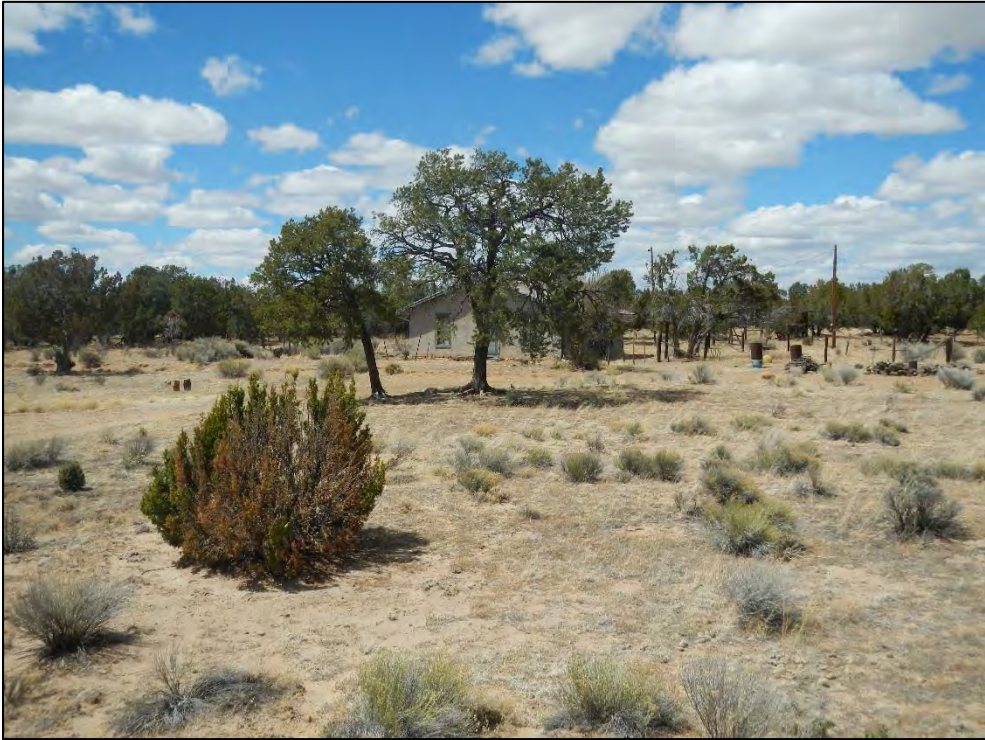
This historic homestead site is located on a hill slope along a west-flowing drainage, extending into a wooded area (Figures 24 through 36). The site consists of an occasionally-used (and maintained) house with several associated structural features, a rock foundation, and a very recent barn. Vegetation consists of piñon, juniper, grasses, forbs, and patches of pale wolfberry. Surface visibility is between 51 percent and 75 percent.

Figure 25: LA 179153 Site Overview Facing North/Northeast (top) and Facing North/Northwest (bottom).

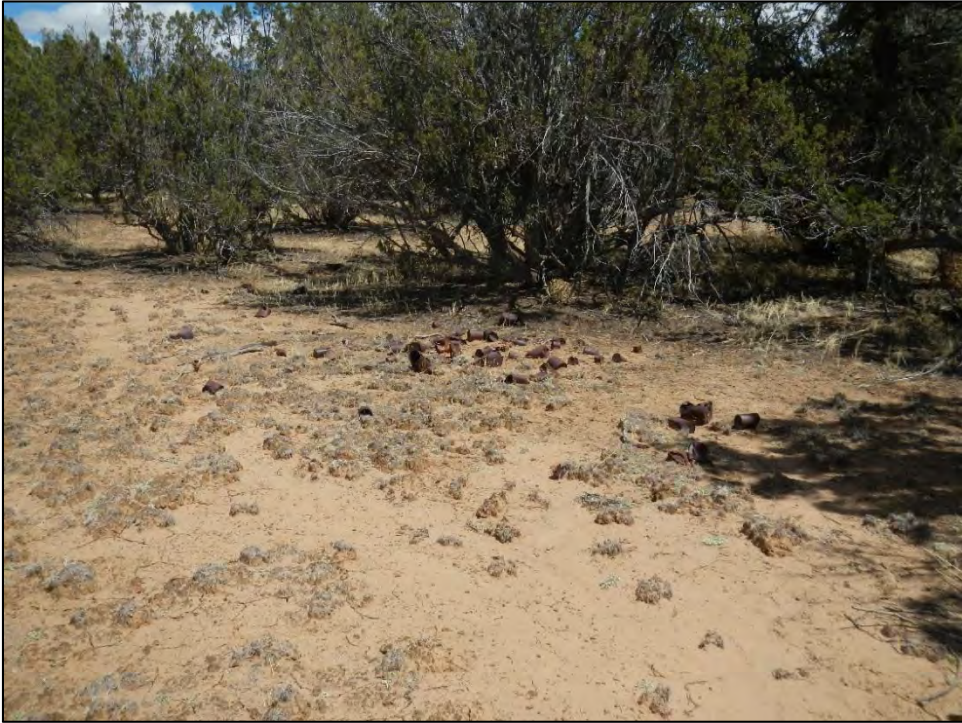
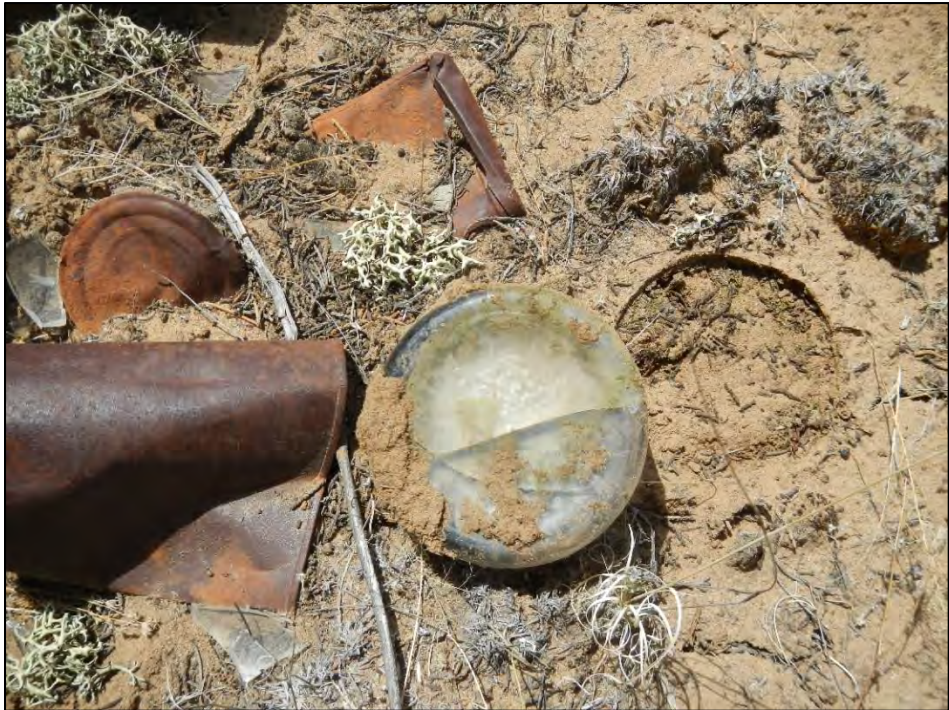
Lone Mountain found a can dump and several features associated with the homestead. Most historic and prehistoric artifacts are located to the north of the standing structures. Artifacts are especially dense along a cleared powerline to the north of Feature 1 (the house). The can dump falls within an area about 3 m in diameter and consists of 25 sanitary cans, 10 vent-hole cans, 10 rotary-opened can lids, a lard pail, several clear and amber glass shards, and white-glazed semiporcelain sherds (Figures 25 and 26). Five fenced areas were observed within the site that were not given feature numbers because they were not clearly more than 50 years old. Three are corrals (Figures 27 and 28). One is a 22-m square coyote-fenced corral (Figure 28) located east of a windmill (Feature 2) and south of a storage cellar (Feature 3). One fenced enclosure surrounds Feature 1. A recent barn has been constructed by the current land owner (Figure 28).

Figure 26: LA 179153 Can Dump Facing East (top) and Can Dump Artifacts with Maker's Marks (bottom).

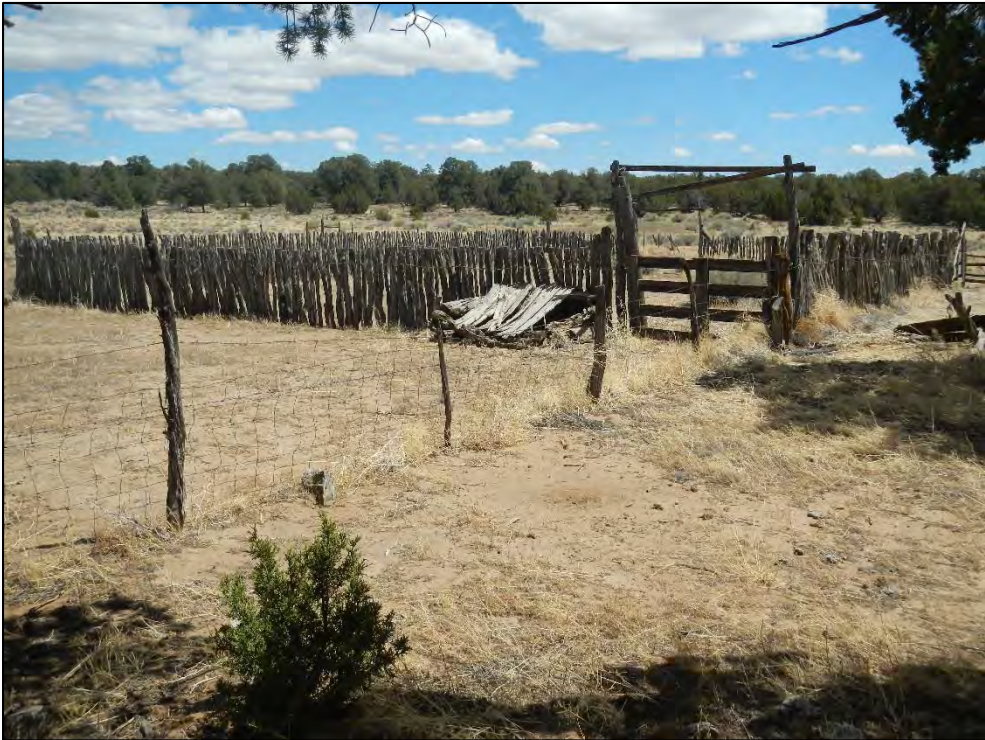
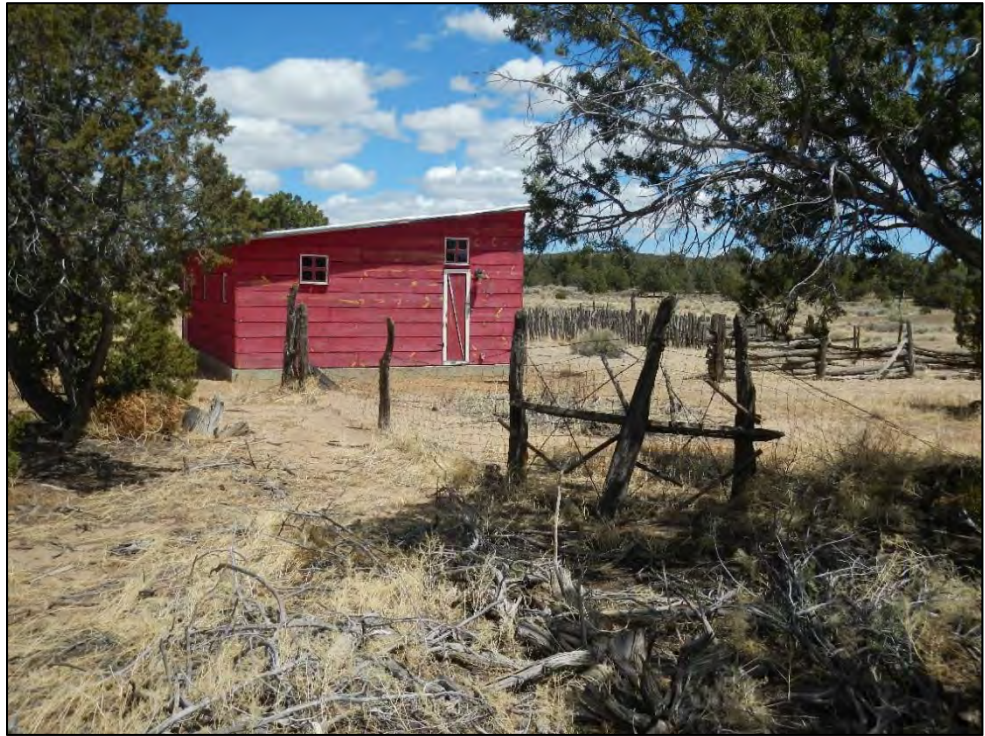
Feature 3 is a wooden cellar or storage bin built in to a corral fence (Figure 34). The cellar measures 9 m by 4 m and is made up of horizontal logs with a plank lid or roof. The feature is deteriorating through weathering and is no more than 50 percent intact.

Figure 28: LA 179153 Coyote Fence Corral/Cellar (F3) Facing South (top) and Recent Barn Facing Southeast (bottom).

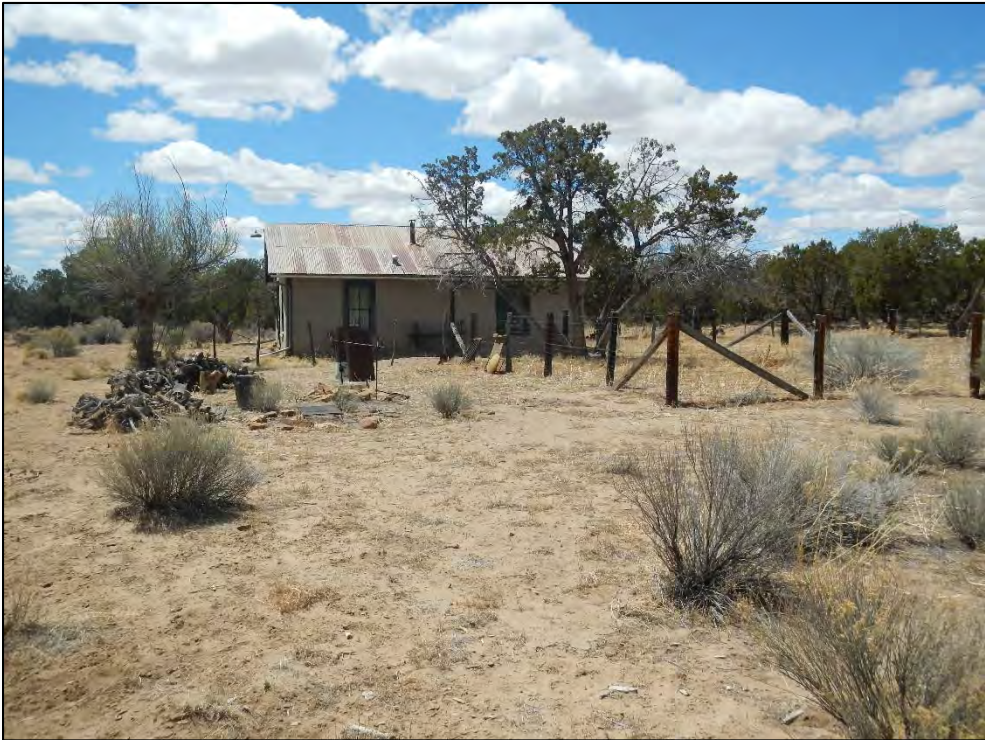
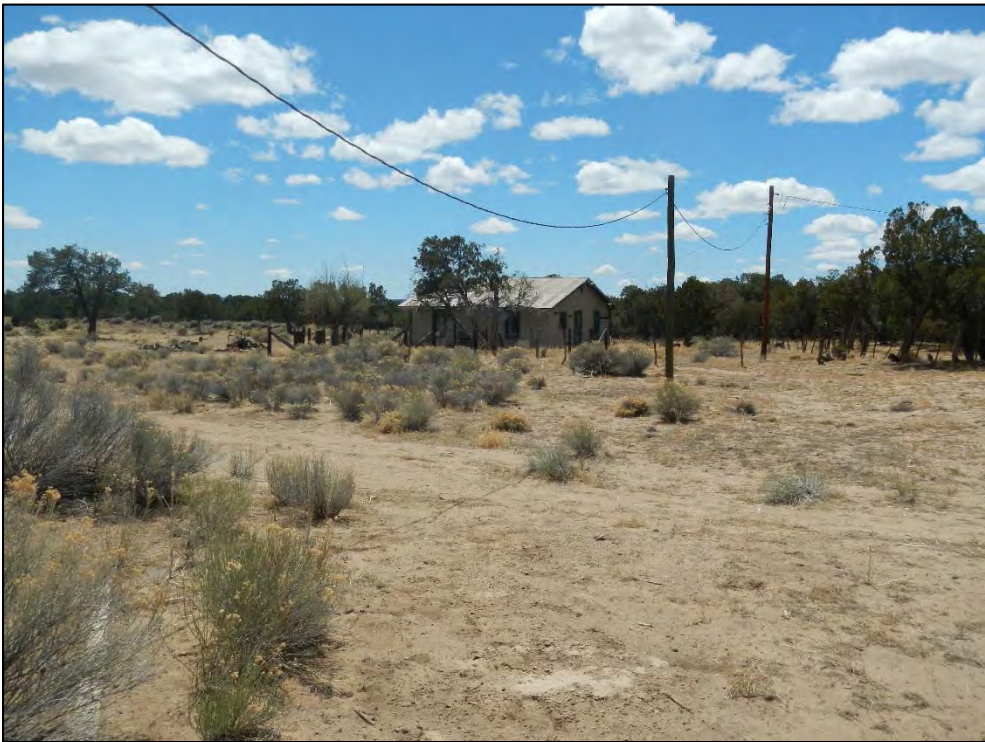
Feature 1 (HCPI 33694) is a single story stuccoed adobe house measuring 9 m by 10 m (Figures 29 through 32). The house is fenced in, with a small number of artifacts along its periphery. The house is front gabled, with a medium-pitched corrugated metal roof. There are screen and wooden doors on the front and rear of the home with eight wood-framed windows. The house is built on a low sandstone slab foundation, visible in places. The foundation's similarity to foundation features at LA

179150 ad LA 179151 suggests that the features on those sites may have likewise been the foundations of adobe homes. The home is currently maintained and is estimated to have 95 percent integrity.

Figure 29: LA 179153 Feature 1 Facing Northwest (top) and Facing Southwest (bottom).
