MEMORANDUM

DATE: April 9, 2004
FILE: Miscellaneous Field Report
TO: Nancy Cunningham, Water Resource Supervisor
FROM: Joseph Fields, Water Resource Specialist
SUBJECT: Atarque Lake, Declaration of Ownership of Surface Waters Perfected Prior to 1907, Gallup Basin

Atarque Lake Declaration Field Report

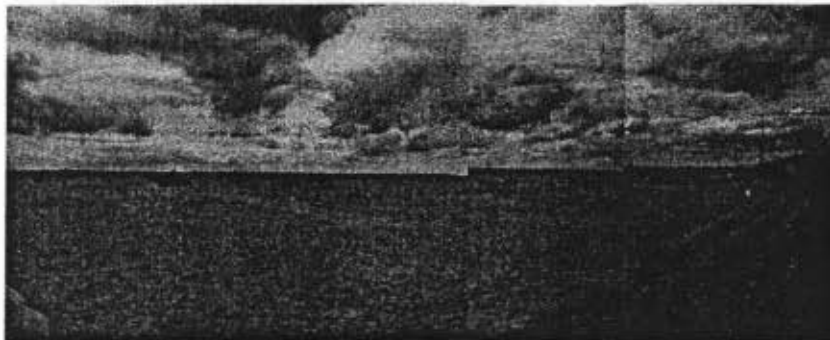
Figure 3: The view is looking southwest across the dry lakebed from the ranch compound.

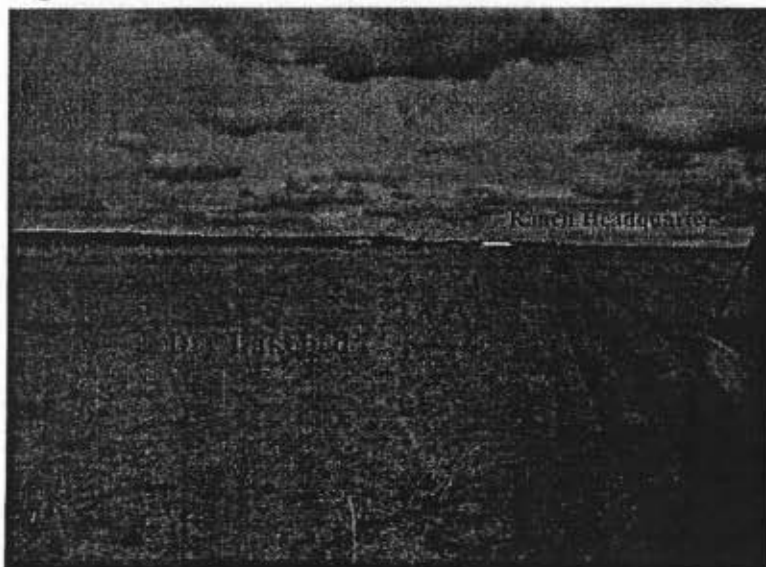
Figure 4: View is of the dry lakebed looking north back to the ranch compound. The picture was taken from a road that crossed the middle of the old lake (see map for approximate location). Figure 5 shows the lakebed looking north from the same location.

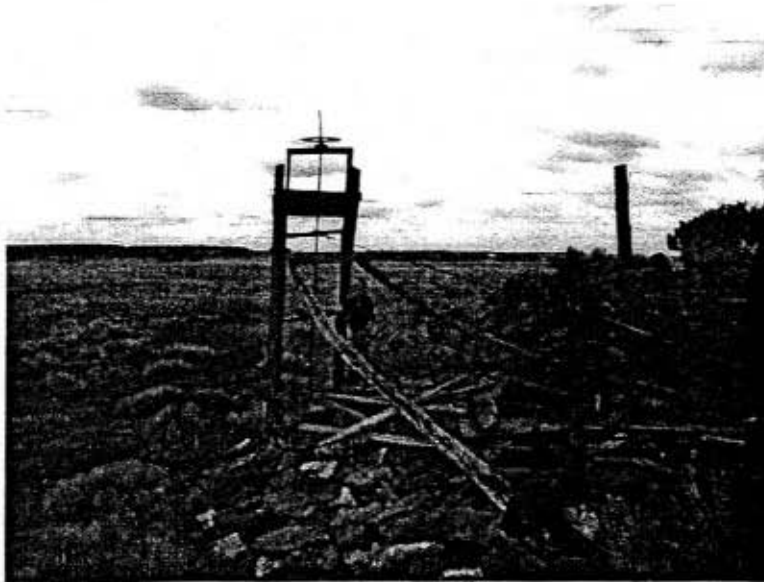
Figure 8: Close up of the water gate valve works and view of the dry lakebed looking northeast. The ranch compound is the white building located to the right of the gate valve.

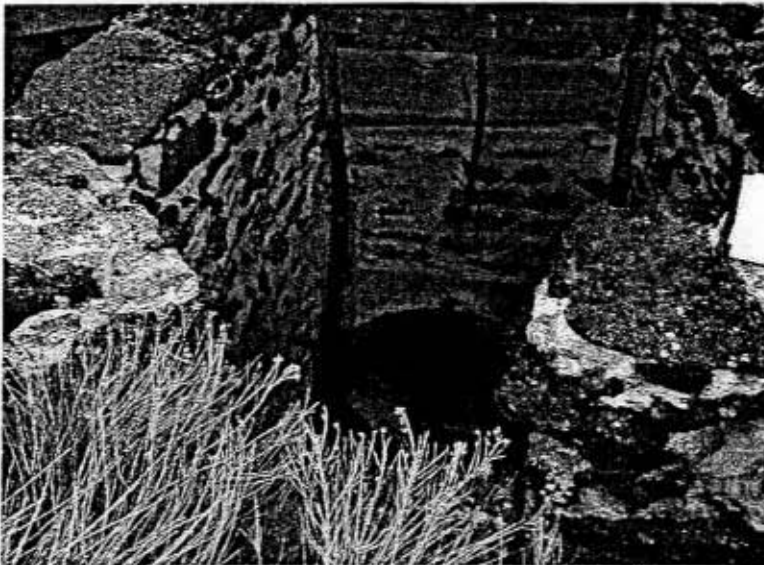
Figure 9: View is of the lakeside inlet gate valve at the remains of the Dam. The gate is not in working condition.

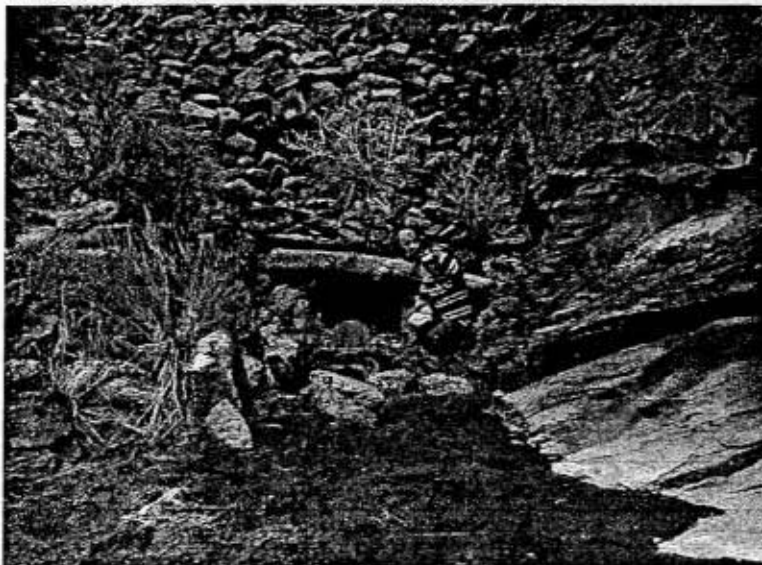
Figure 10: View of the Canyon side outlet at the remains of the Dam. The gate valve works are the only remaining vestiges of the Dam works and are not functional.

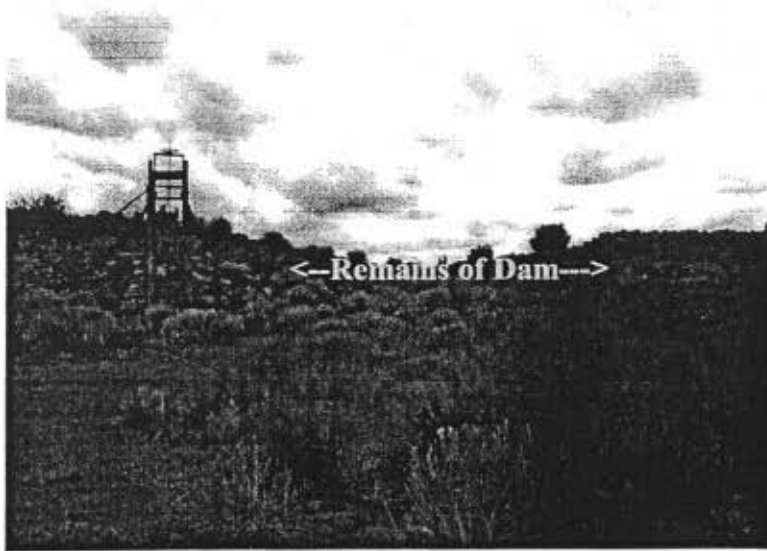
Figure 11: View shows the remains of the Dam and gate valve works from as seen from the Lake. The Dam has been functionally destroyed and would have to be completely rebuilt in order to impound water again.

Per the 1972 USGS 7.5 minute topographical map, Atarque Lake was classified as "Dry Lake Bed" and remains so. In the replacement Declaration, Mr. Shoenfeld stated that "The dam was destroyed by 1971 and the water has not been used since that time". Apparently, the dam was destroyed in the early 1970's and the lake drained. The statements in the Declaration correlate with the status of the Lake as shown on the 1972 USGS Map. Inspection of the dam itself revealed that it has been functionally destroyed and what is left is no longer operable. In order to impound water again, the entire dam works would have to be completely rebuilt. Water can no longer be impounded and any runoff flows through braided channels in the lakebed through the remains of the dam into the canyon.

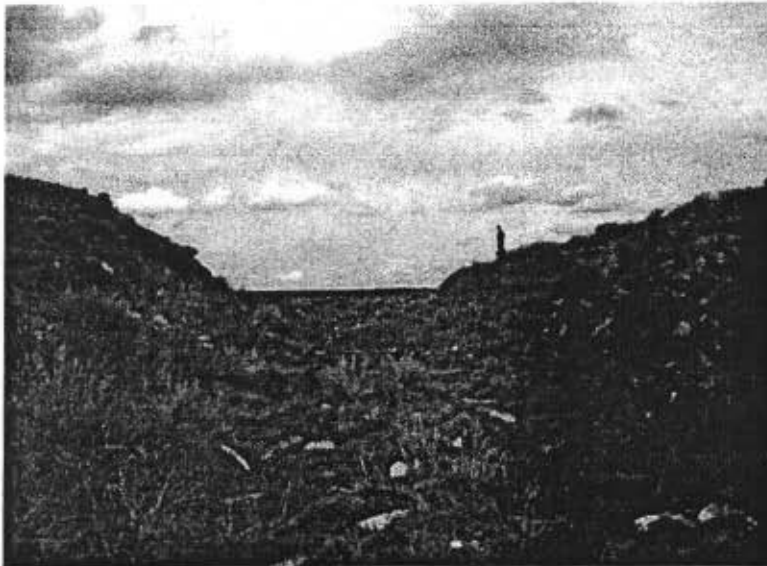
Figure 12: View shows the Dam destroyed as seen from the canyon looking north into the dry lakebed.
